# Studebaker

# Service Letter

**SUBJECT** BATTERY DISCHARGING -  
STATION WAGON MODELS WITH  
ELECTRIC-TYPE TAIL GATE WINDOW

**NUMBER** J-1964-3

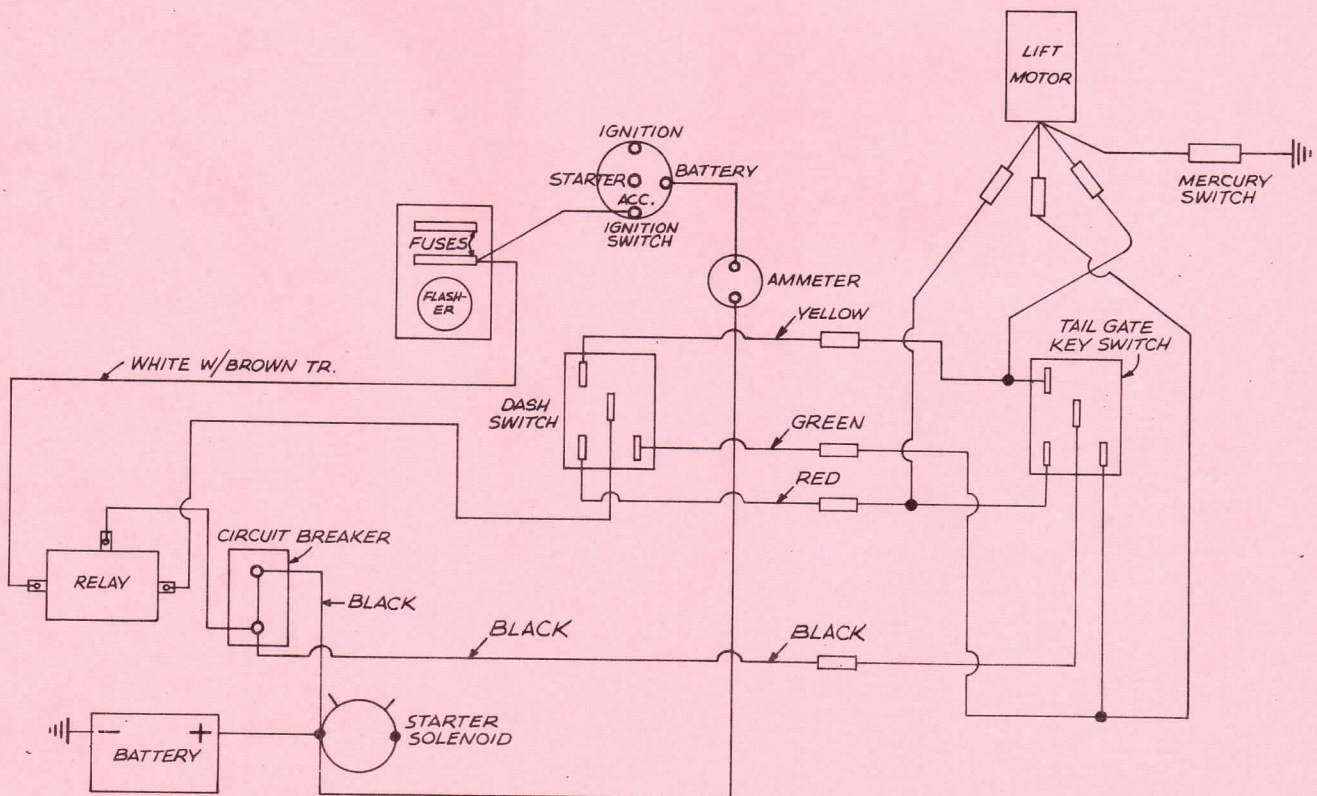
When you encounter a condition of the battery "running down" on 1964 Station Wagon models equipped with an electrically operated tailgate window, the condition is probably caused by improper wiring of the tailgate relay to the fuse block and directional signal flasher assembly.

Check the connection of the white wire with brown tracer that leads from the fuse block to the fender mounted tailgate relay and ascertain that it is connected to the terminal on the fuse block and flasher assembly which is closest to the flasher and toward the centerline of the car. A white wire with black tracer, which leads to the accessory side of the ignition switch, is also connected to this terminal.

Where you encounter this condition, the connection between the relay and the fuse block should be checked and corrected as follows:
