Dave Carnock's Very Unique Wagonaire

1963 Daytona
Champagne Gold
Green Interior
Final Assy.:
05/09/1963
Drum Brakes
Dual Master
Cylinder
Power Steering
Air Conditioner
3.31 Differential
Push Button AM
Radio

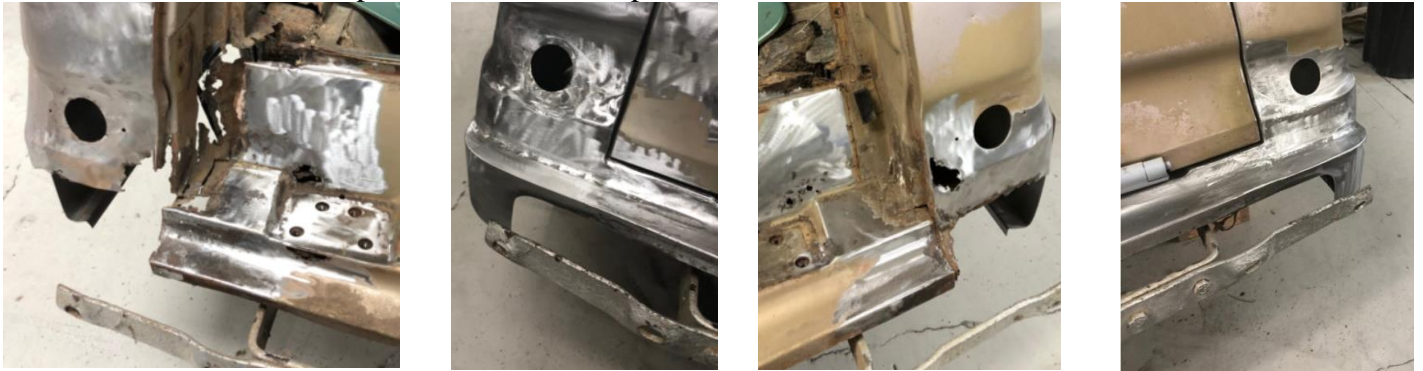
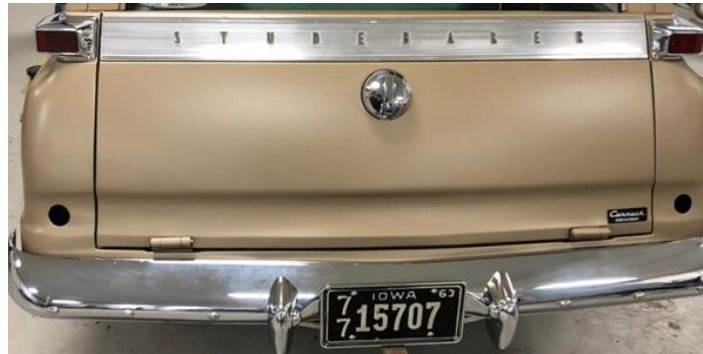
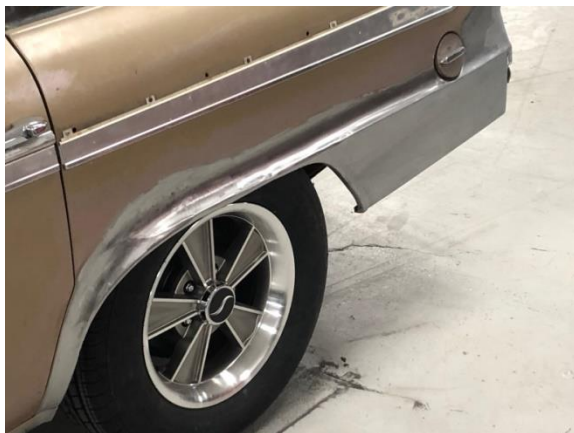
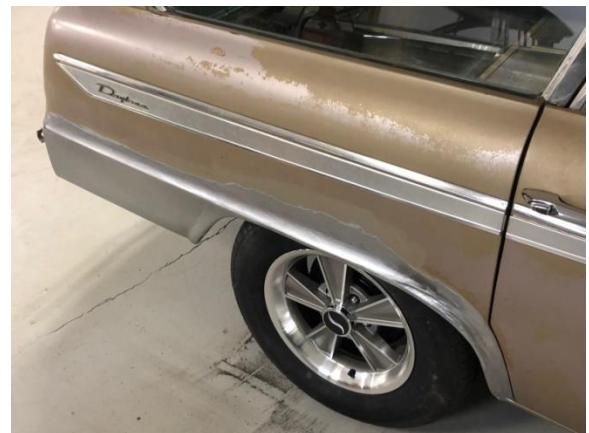
Previous attempts at repairs on the body of the wagon were terrible at best. Tons of Girl Scout cookie tins had been sacrificed; many cans of bondo emptied, yards of fiberglass used, and a little roofing tar for good measure were evident in all the known and usual Studebaker rust spots and some spots probably unique to this car. The crowning touch in all those previous "repairs" was the use of metal door frames from a house door, complete with the dead bolt holes, having been used for rocker panels! It was a mess to say the least.

The front floor boards were replaced and the floor braces were replaced along with the lower cowl. The lower quarter panels were also in really bad shape and needed a lot of new metal. The rear jamb across the back under the tailgate had to be rebuilt. These body parts are no longer readily available, if they can be found at all, so Dave fabricated the new panels in his own shop. .

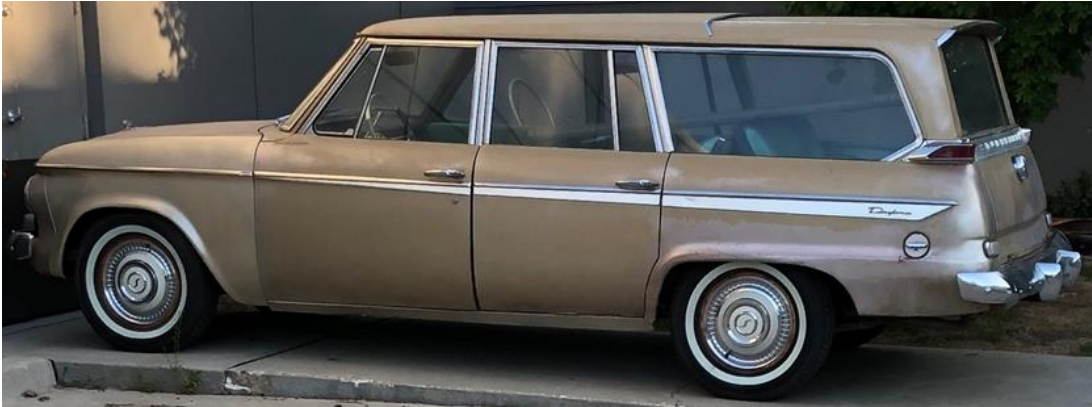
With the engine in and the body work completed, it was time to figure out what to do about the paint. In keeping with his goal of having a car that looks like an original old car rather than a freshly restored one, Dave decided to only paint the car from the windows down. The upper part of the car was still in good shape. The lower body however, addition to the areas that had required extensive repairs, also had mismatched front fenders and hood. This photo was taken the day the Wagonaire arrived.

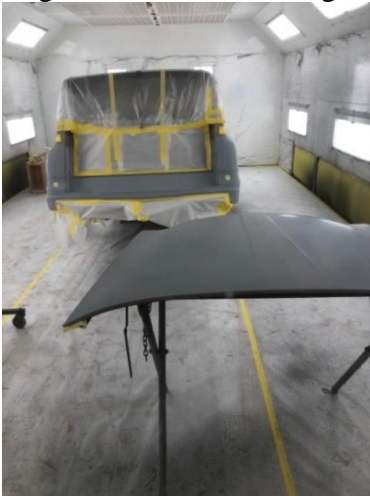
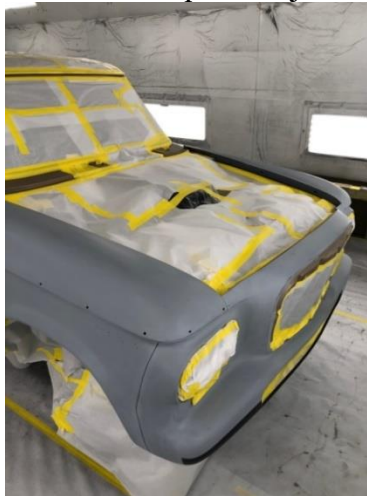
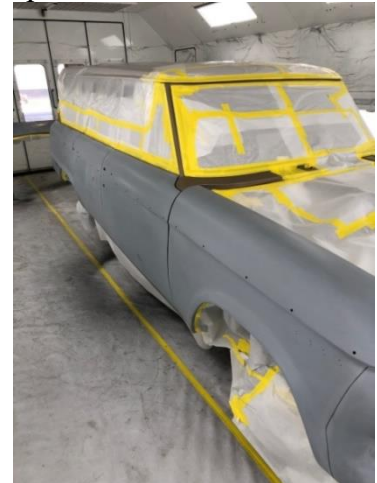
He did his best to match the original color of the roof. He even mixed his own clear coat in order to get the same sheen on the lower body as was evident on the faded roof. The hood and the tailgate were painted separately. The paint on the lower door jambs was spotted in as need from rust repairs but the rest of the jambs looked good and were left original. Dave calls this a "quickie" job but it looks professional to me.

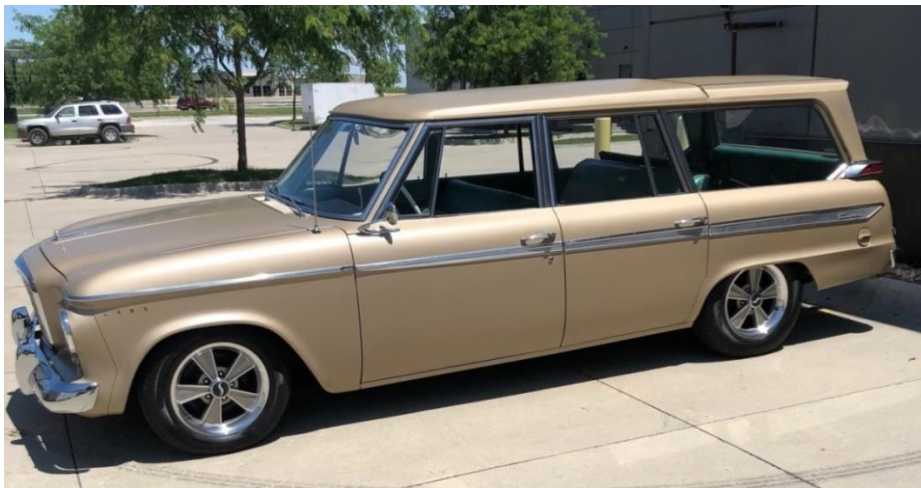
THE FINISHED PRODUCT

All of the chrome and stainless on the car is original with the exception of the bumpers. Dave secured two NOS 1964 Wagonaire bumpers and bumper guards and installed them on the car.

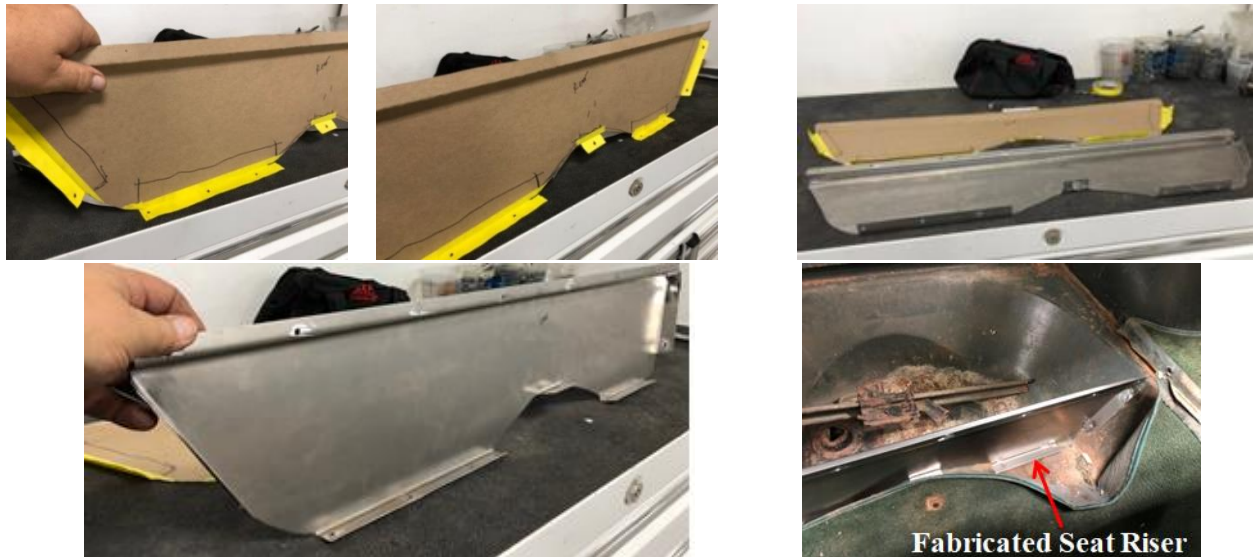
FABRICATING THE SEAT RISER

Information on the third seat in a Wagonaire is difficult to come by at best. There is nothing in either the parts manual or the shop manual to give you any idea of how it was designed. The Wagonaire Registry has several owners who, like me, are also trying to put a third seat to their Wagonaire. With Dave's fabrication skills along with a combination of rough drawings, pictures of actual third seats in Wagonaires, and the pattern of the holes in the spare tire wheel well floor, Dave was able to reproduce the Seat Riser missing piece exactly.

Dave has been kind enough to send me a copy of the pattern he used to make the seat riser for the Hideaway seat. He has also given me permission to send a copy of it to any other Wagonaire owner who might need it while trying to get a Hideaway seat installed in their Wagonaire. Thanks, Dave, for your kind gesture.

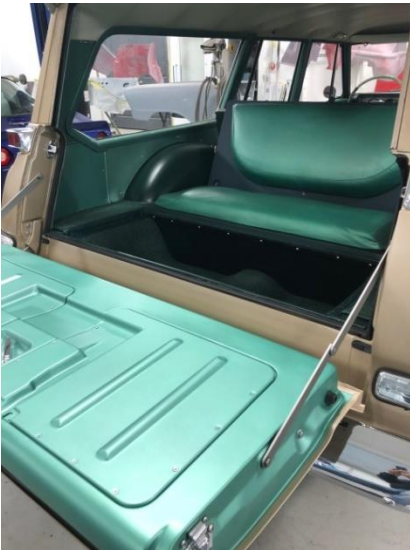
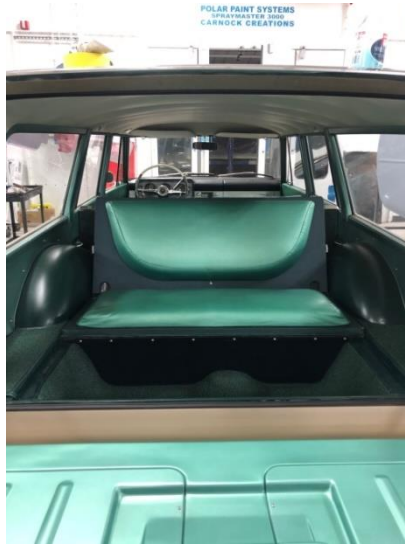
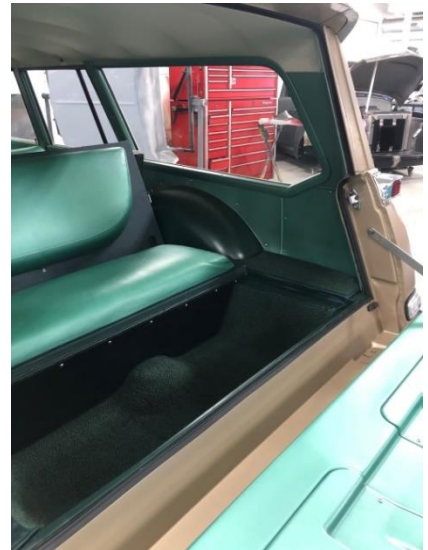
THE BOTTOM OF THE 3RD SEAT FOLDS FORWARD, THE BACKREST THEN FOLDS DOWN

Without a doubt, the most challenging aspect of dealing with the interior was the restoration of the Hideaway Seat in the back of the Wagonaire. The third seat of a Wagonaire was designed to fold down into the space normally used to store the spare tire. To compensate for the lack of a spare tire the cars came equipped with "captive air" tires. At some point in its past a prior owner of this Wagonaire had become disenchanted with the captive air tires and opted for having a spare. The seat riser in the wheel well that allowed the third seat to be used had been removed and was no longer with the car. Luckily, the actual seat and other hardware were still in the car.

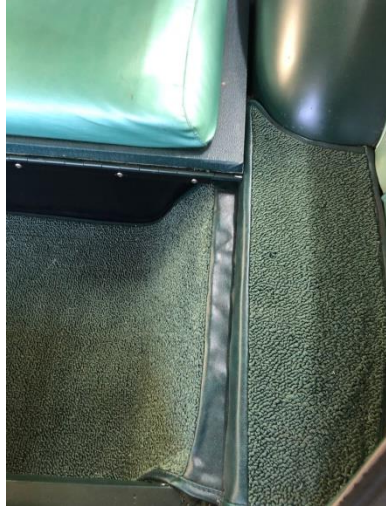
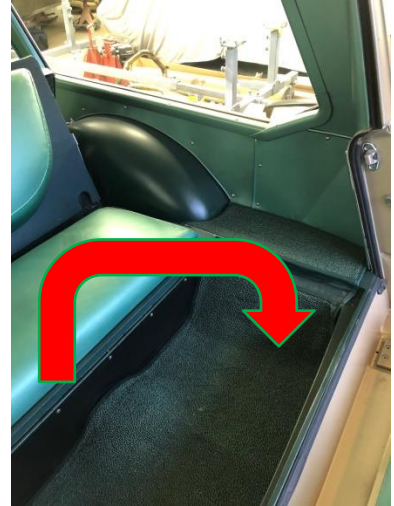
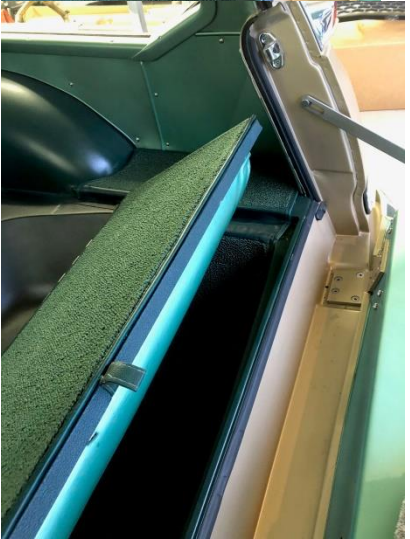
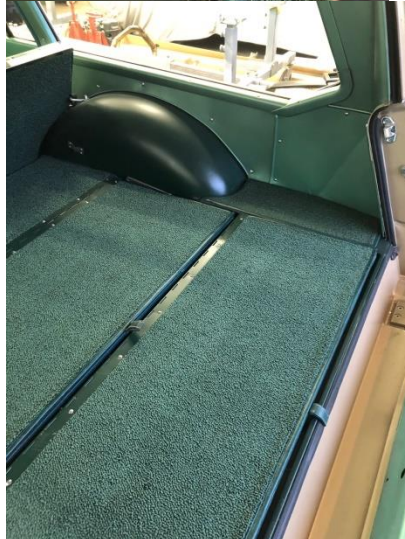
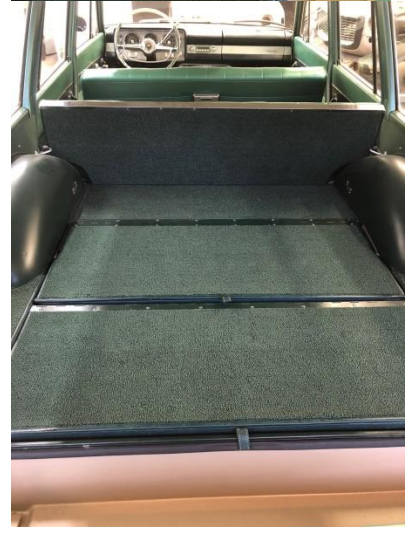
The side panels behind the second row seat, shown above, are the original materials but they were removed and freshened up a little to be compatible with the look of rest of the interior. All of the carpet in the Wagonaire has been replaced using the original as a pattern.

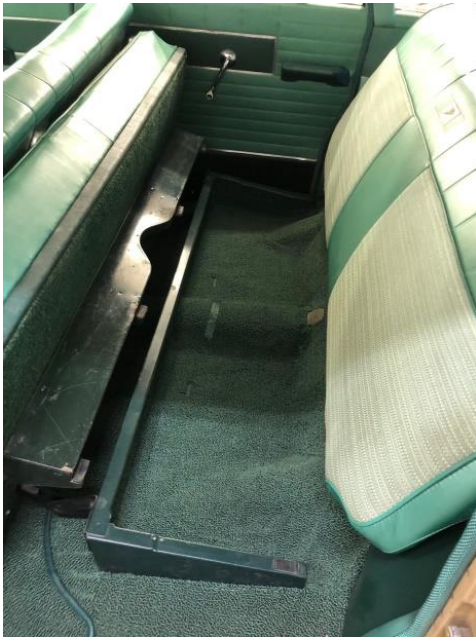
The carpet under the middle seat was added to deaden sound and to protect anything stored

there. That is not original.

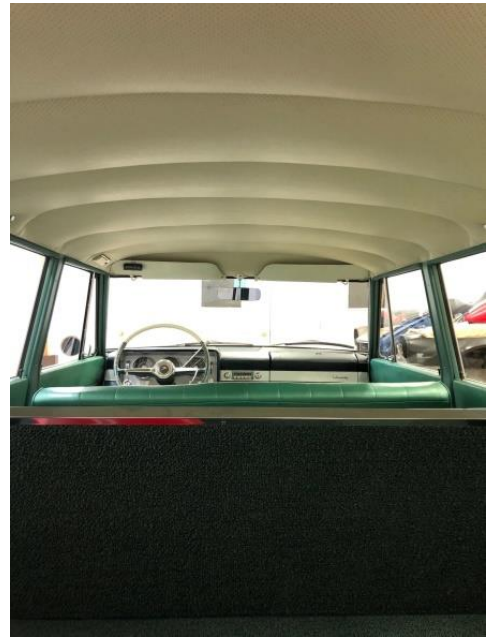
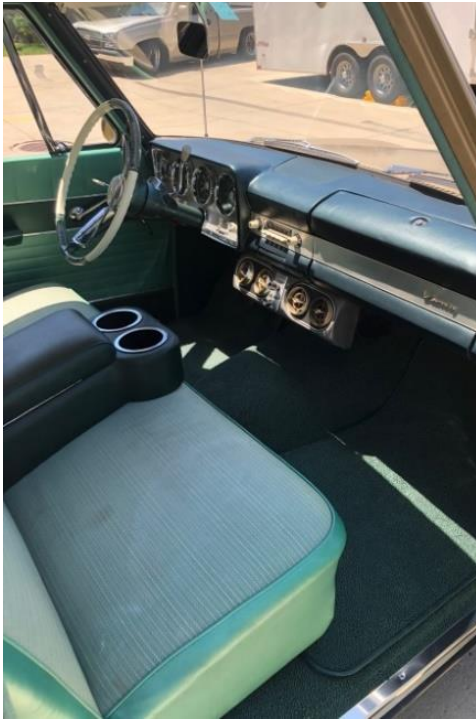
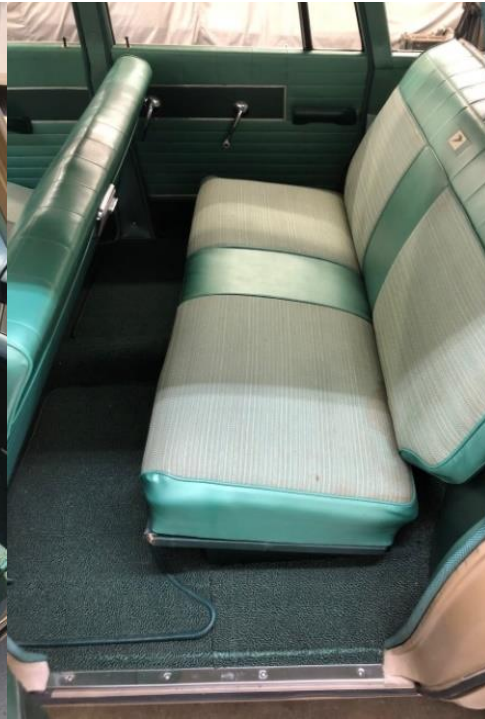
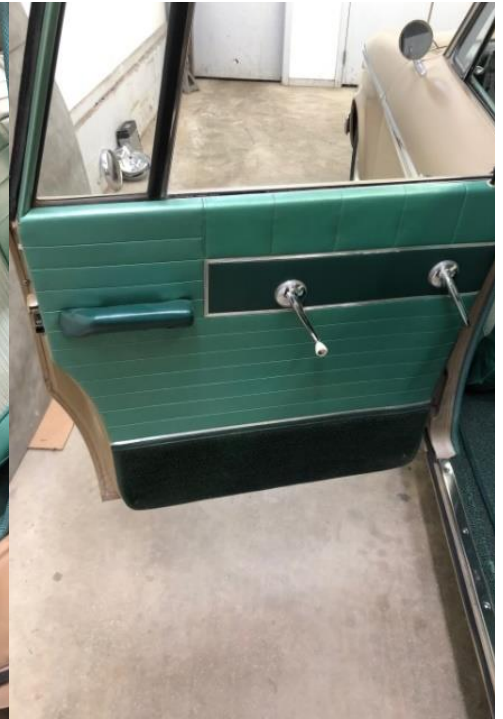
When it comes to a headliner in a Wagonaire, the owners of the fixed roof units win that contest hands down. Sliding roof units had a printed, cardboard like headliner that has rarely survived and replacements have been unavailable for a long time. The fixed roof units have a more conventional headliner and Accurate Auto, using Dave's old headliner as a pattern, provided a good replacement for this Wagonaire.

Surprisingly, even the rubber door seals mostly remain all original. All of the glass in the Wagonaire is the original but the doors and tailgate all have new run channels for the glass.

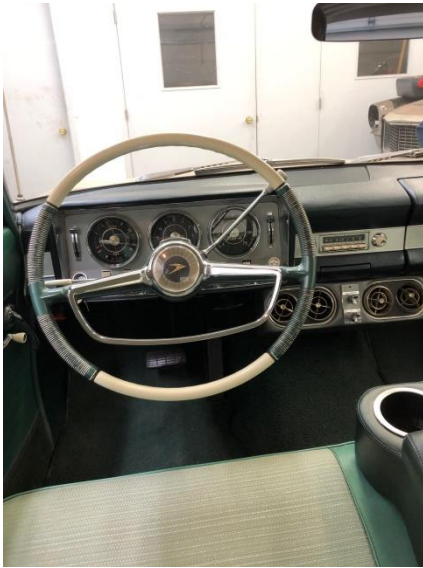
The dash had the usual cracks in it and was repaired and then dyed by Dave. The good looking push button AM radio still functions just fine! The Wagonaire had air conditioning installed by the factory when the car was built. Once again Dave wanted to upgrade the system but keep the look of the original. A complete new system was installed, including the under dash unit, but Dave managed to retain the original look of the under dash unit by adapting the original front plate and vents to fit the new unit. He even managed to use the original knobs. It makes a very nice presentation.

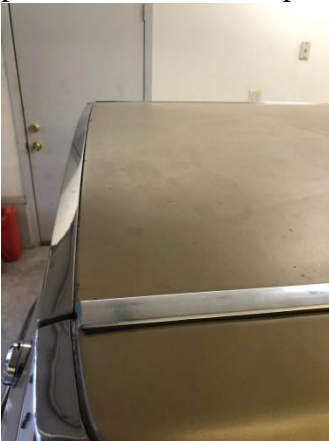
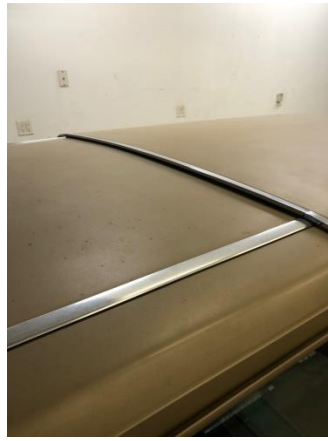
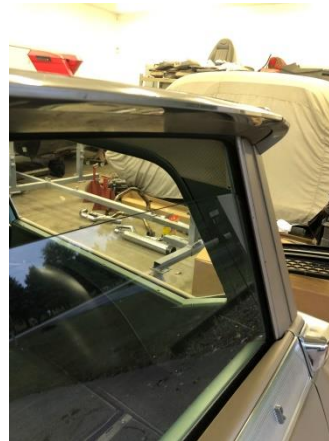
Since I have never seen a fixed roof Wagonaire I was very curious about how they went about making the roof a permanent part of the body. Once again Dave was kind enough to answer my never-ending barrage of questions and provide pictures to make it clearer. Basically the fixed roof was accomplished by simply bolting the sliding roof panel to the body. The panel is bolted to the part of the structure where the sliding rails would be with brackets containing four bolts each. On the seam where the panel meets the existing fixed roof structure there appears to be a gasket as well. To cover the seam on each side of what would have been a sliding panel they used chrome (or stainless steel, I'm not sure which) strips to cover the seam. It makes a nice presentation. See the pictures below.

With a fixed roof the tailgate glass no longer needs the chrome frame around only the glass. It now is fully contained in the window channel of the side and top of the window opening.
