THE 1964 STUDEBAKER WAGONAIRE WINDLACE PROJECT

Windlace

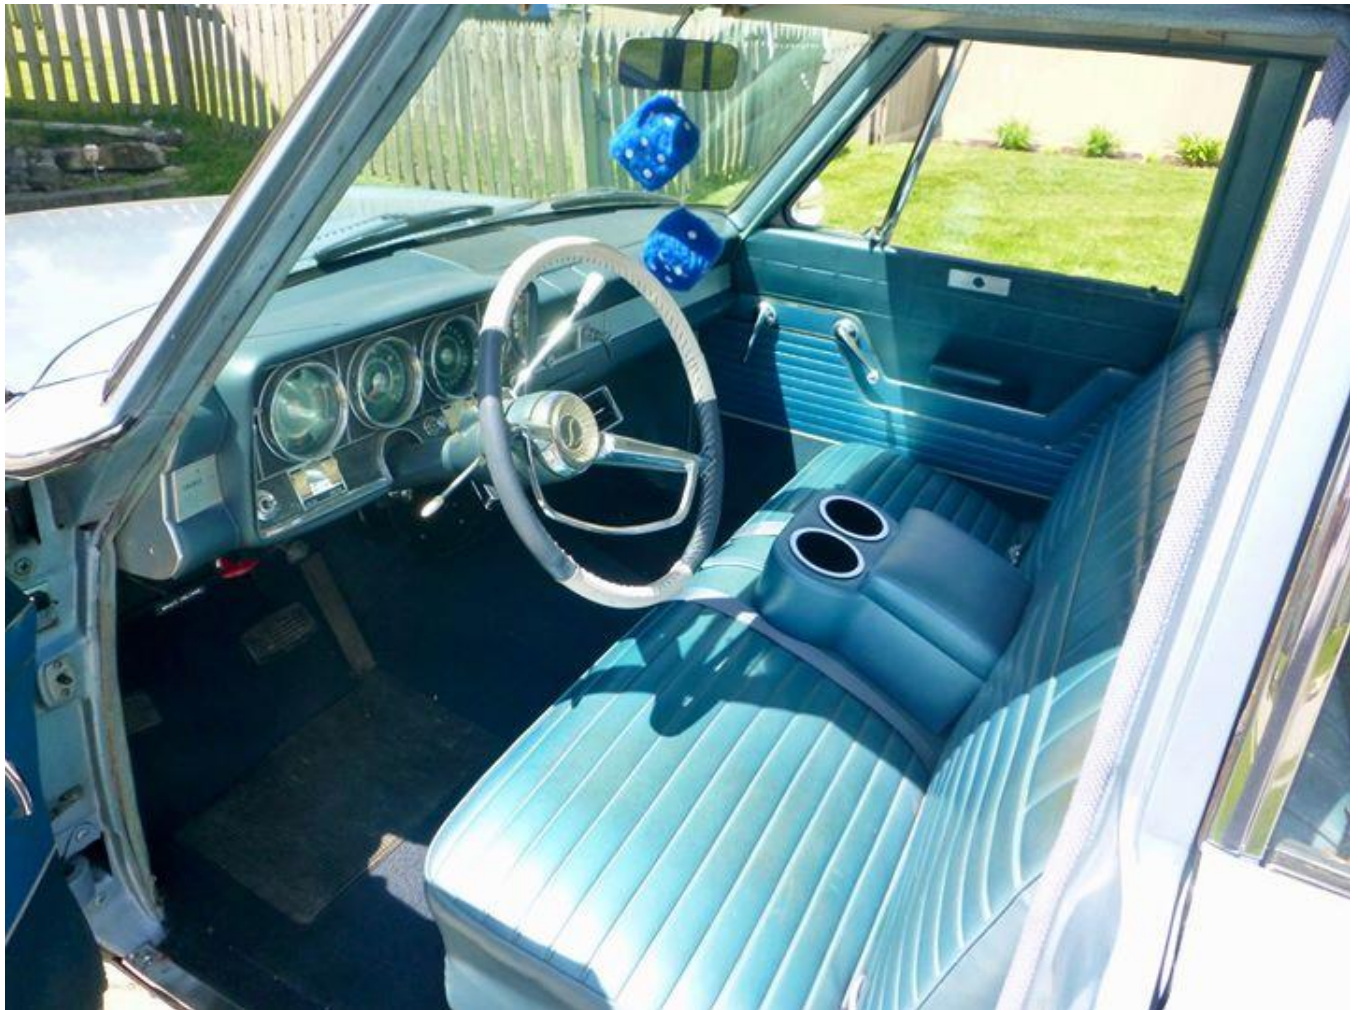
The windlace around the doors is in bad shape. I am undertaking its replacement as a 2020 winter project. For Christmas 2020, I received a gift certificate from Studebaker International which I used to buy the windlace. Original Windlace – previous owner’s photo

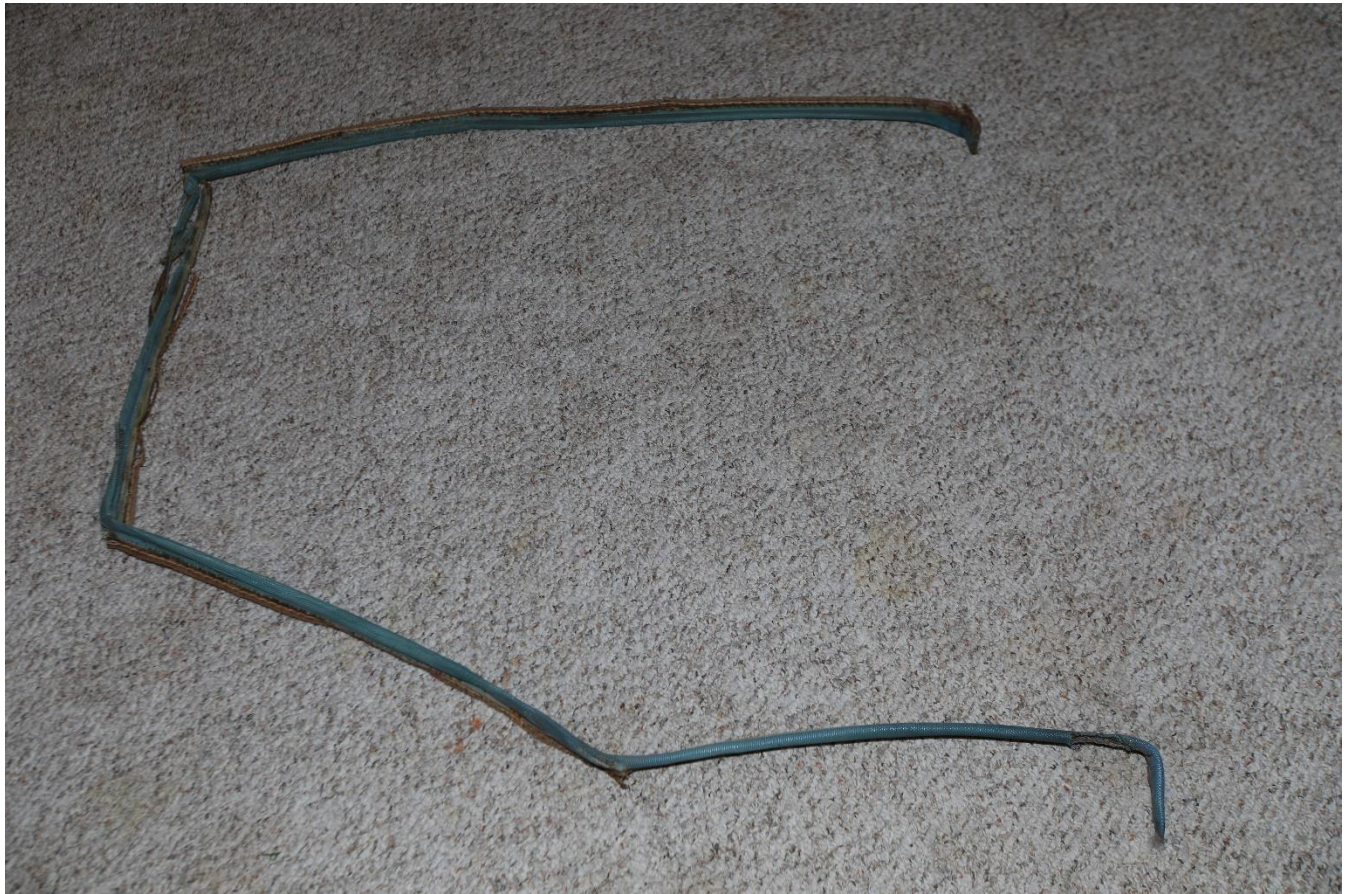
The original windlace was dry, shrunken and shriveled; it never reached to the floor – a piece missing.

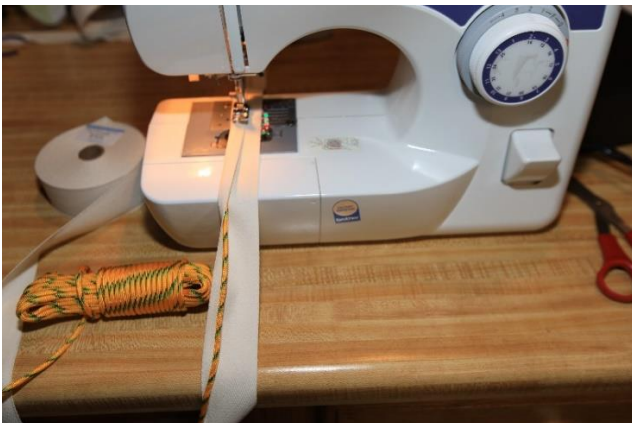
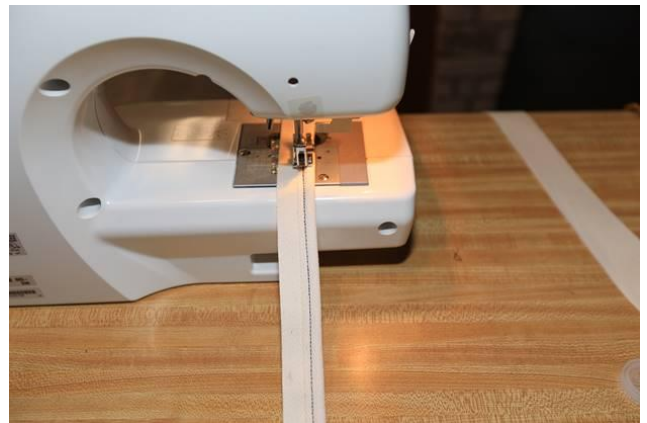
New Windlace with the extra cotton addition sewn on

THE SECOND STEP IS TO MODIFY THE NEW WINDLACE MATERIAL SO THAT IT CAN ACTUALLY BE INSTALLED. The windlace material currently on the market is not made like the original Studebaker windlace. A band of material must be added to secure the windlace into the channels and locking tabs on the doorways. I ordered a roll of 1-1/2 inch wide heavy cotton ribbon from an internet vendor and bought a roll of the smallest diameter cord from Home Depot. Borrowing a sewing machine, I was able to modify the new windlace adding a locking tab to approximate the original.

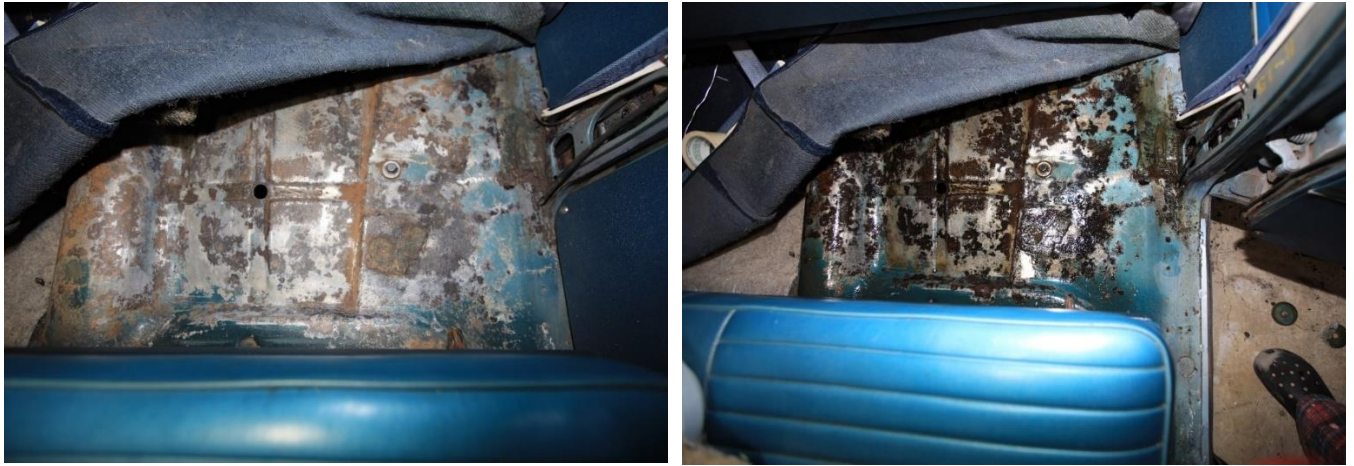
THE FIFTH STEP WAS TO FIX PROBLEMS. As the windlace installation progressed, any problems encountered or revealed were addressed. Existing trim parts that went back on the car that were rusty, worn out, or need a touch up, were restored while off the car. When removing the sill plates, I discovered some light surface rust under the new carpet and padding. I fixed this with POR15.

Treated with phosphoric acid, sanded with #80 sandpaper, and treated with clear POR-15
