Studebaker

Service Letter

SUBJECT RELOCATION OF ELECTRICAL CONTROL UNITS
1963 WAGONAIRE W/ELECTRIC TAIL GATE WINDOW

NUMBER J-1963-12

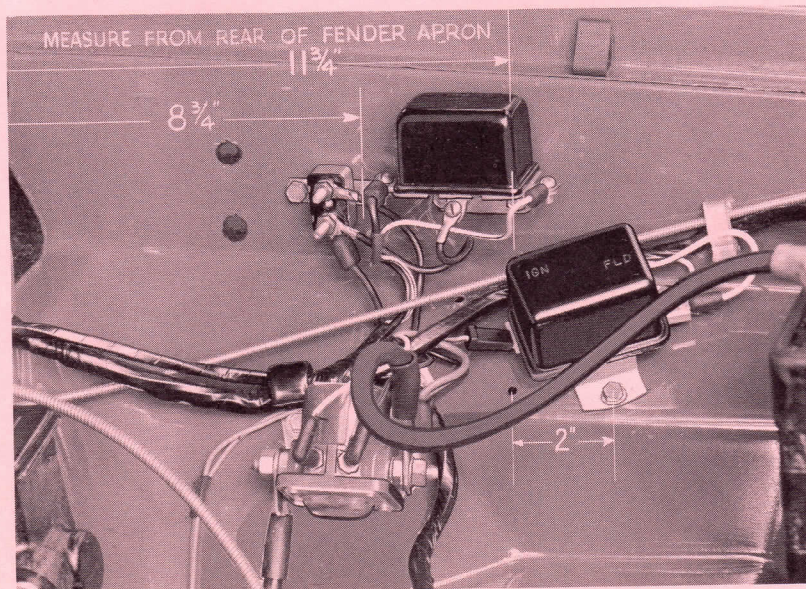
Fig. 1

Effective with serial numbers 63S-26025 and 63V-24019 the voltage regulator, tail gate window lift relay and circuit breaker on 1963 Wagonaire models equipped with an electrically operated tail gate window have been relocated further forward on the left front fender apron to eliminate possible interference between the wiring and the hood torsion bar linkage.

You should inspect all 1963 Wagonaire models with electrically operated tail gate windows for interference at this point when the vehicle is in your service department. If interference exists, the voltage regulator, lift relay and circuit breaker should be repositioned as indicated in Figure 1. After relocation of these units, the unused holes in the fender apron should be plugged.
