Studebaker

Service Letter

SUBJECT ELECTRIC TYPE DOOR WINDOWS AND TAIL GATES
AVANTI AND STATION WAGON MODELS

NUMBER J-1963-10

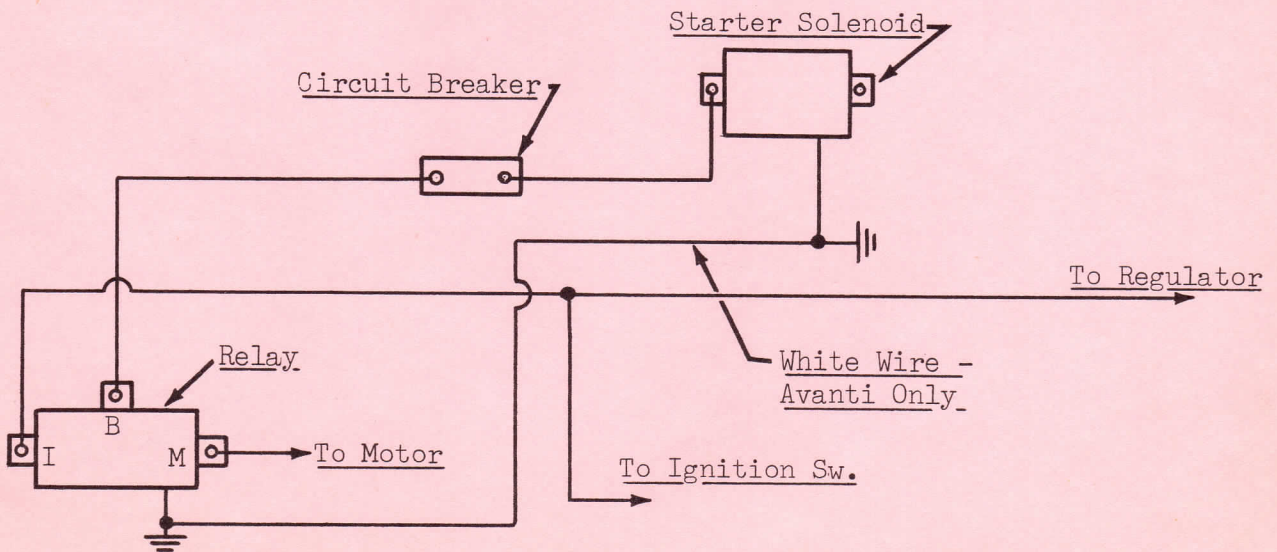
1. Connect a jumper wire between the rear terminal (M) and the center terminal (B) of the window lift relay located on the left front fender apron.
2. Leave the ignition switch in the 'OFF' position and operate the window lift motors as required while servicing the windows.
3. Remove the jumper wire from the window lift relay after the servicing work is completed.

When it is necessary to service the electric door windows on Avanti models or the electric tailgate window on station wagon models, use the following procedure which will enable the windows to be operated without turning on the ignition switch:
